Public Safety DAS

CASE STUDY

Emergency responder radio coverage signal failure resolved with a Public Safety Distributed Antenna System (DAS)

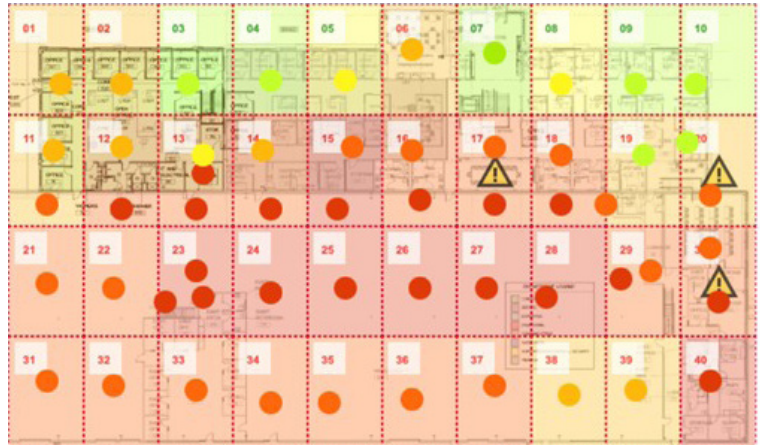
BEFORE

Buist identified a critical need to improve emergency communication capabilities within our headquarters. While traditional two-way radios worked adequately, we discovered coverage gaps in certain areas of the building, particularly on the lower levels and in interior rooms.

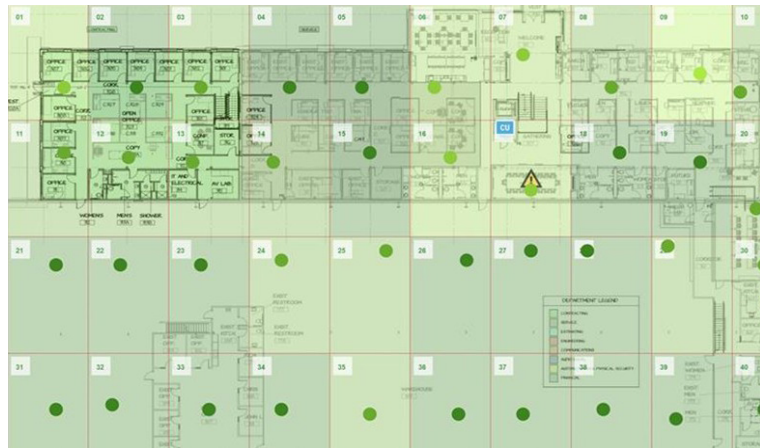
AFTER

After installation, a post survey showed significant improvement. Areas that previously had weak or no coverage, especially interior rooms and lower-level spaces, now had strong, consistent signal. The entire facility benefited from dependable communication capability, ensuring first responders have full access in the event of an emergency. This project highlights Buist's dedication to **Raising The Standard** in the technology industry, safety, and beyond.

To meet NFPA requirements and ensure reliable emergency communication, we installed a Public Safety Distributed Antenna System (DAS), also known as an Emergency Responder Communication Enhancement System (ERCES). Designed to improve in-building radio coverage, an ERCES enables first responders to maintain clear communication during emergencies. Buist conducted a site survey to assess signal strength and designed a system tailored to the facility. The DAS captures and distributes 700/800 MHz signals through strategically placed antennas and equipment, providing consistent coverage throughout the building.
